# ANNUAL REPORT FOR 2009

**Unnamed Tributaries to Doby Creek Mitigation Site  
Mecklenburg County  
TIP No. I-3803A**

Prepared By:  
Natural Environment Unit & Roadside Environmental Unit  
North Carolina Department of Transportation  
October 2009

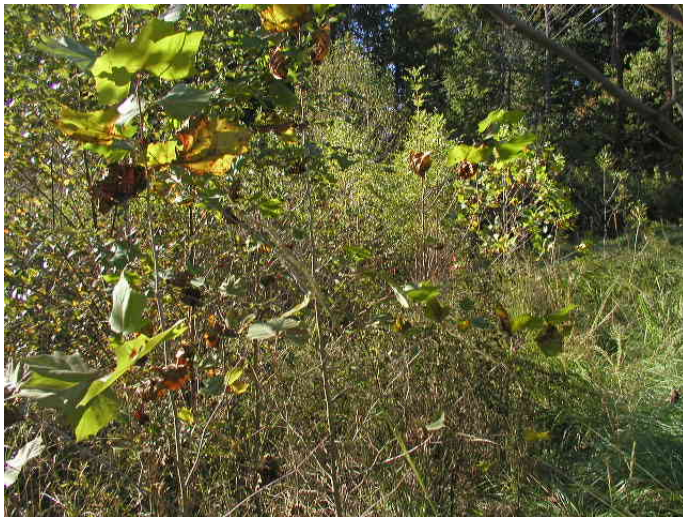
Photo Point #1 (Vegetation Plot 2)

**Site Notes:** Other vegetation noted: *Juncus* sp., cattail, woolgrass, tear-thumb, goldenrod, and various grasses. There was some missing planted vegetation within vegetation plot #2 due to the beaver activity but other hardwood vegetation (i.e. black willow and tag alder) were still abundant.

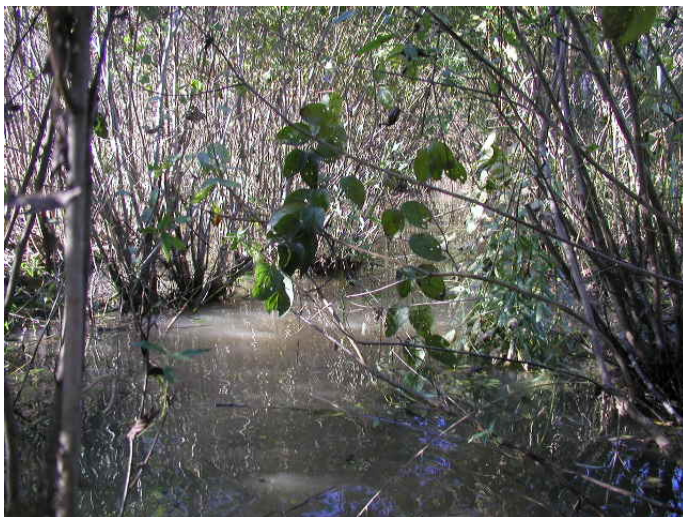
Photo Point #2 (Downstream @ X-Section #2)  
October 2009

Based on comparisons of 2008 to 2009 monitoring data, both cross sections appear stable with little or no active bank erosion. It was noted on the graph for cross section #2 pool that some of the sediment deposited into the channel from last year has moved downstream. The beaver dam located downstream of photo point #3 has caused some aggradation along the lower end the stream restoration project. Debris deposited onto
